968 SHIFT LINKAGE

Removing and Checking the Shift Lever

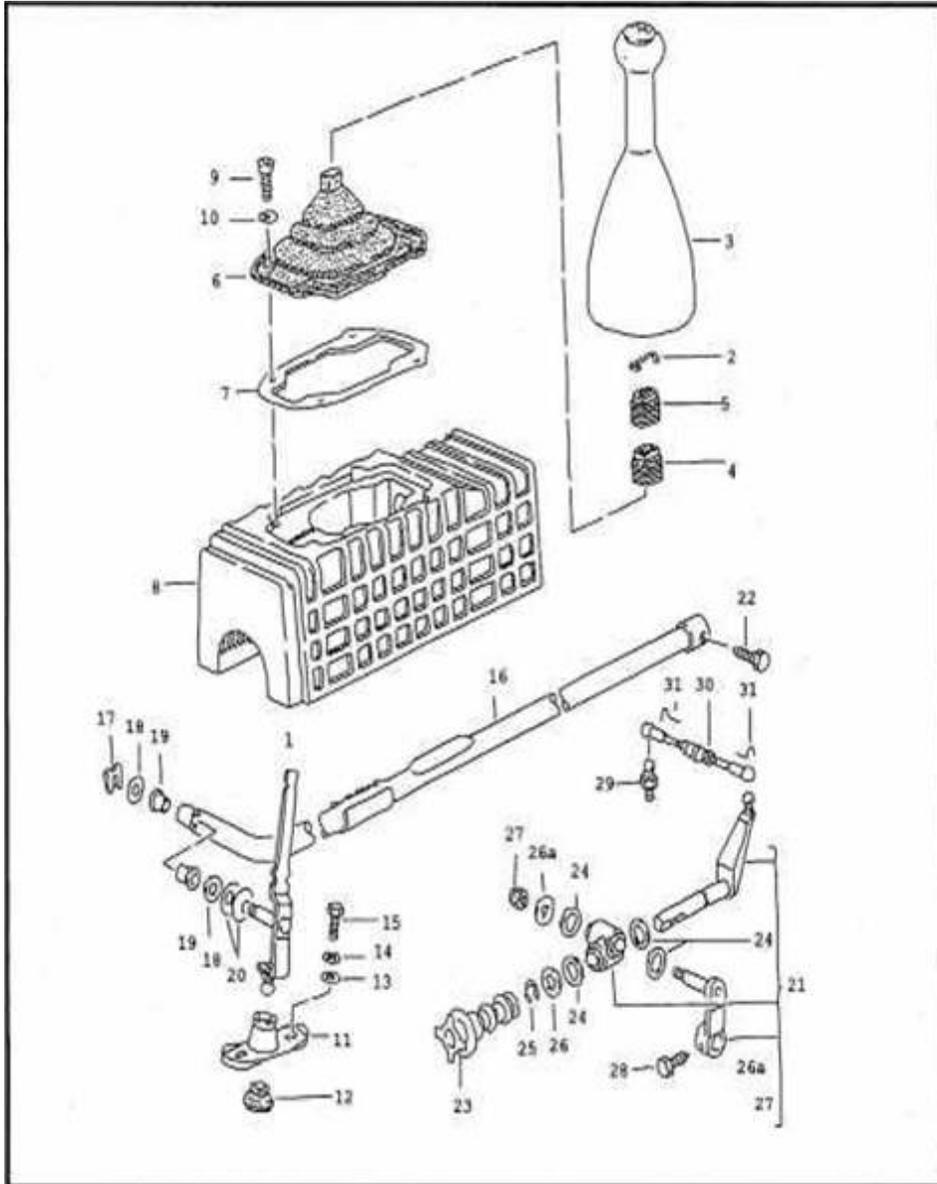
968 Shifter / Linkage Parts		
Shifter Parts		
Part Number	Description	Drawing ID
944 424 015 02	Shift Lever	1
N 012 648 2	Spring Clip	17
944 424 231 00	Bearing Shell	12
Transaxle Linkage		
944 424 013 01	Intermediate Shift Lever	21
999 167 046 00	Ball Pin (2 required)	29
944 424 041 02	Articulated Shaft	30

3. On 968s with plastic trim around the shifter boot perform the following (Refer to 968 Shift Linkage Drawing for Location Numbers):
 - a. Using a flat tip screwdriver gently pry around the base of the shifter boot next to the console. Be careful not to damage the boot. This will separate the boot and inner trim ring from the console.

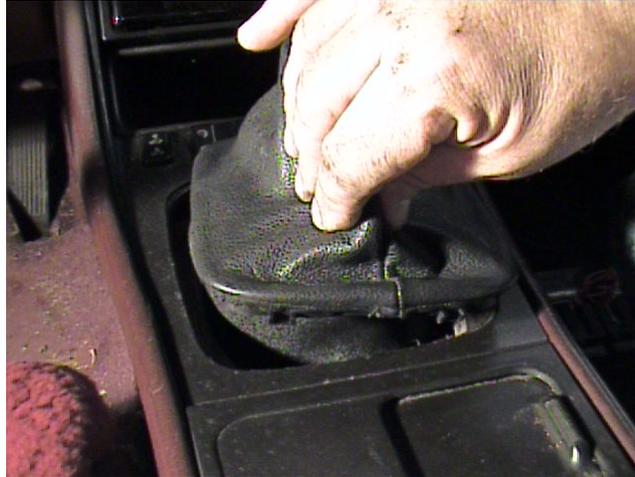
2. On later 944s with plastic trim around the shifter boot perform the following (Refer to 944 Shift Linkage Drawing for Location Numbers):
 - a. Using a flat tip screwdriver gently pry around the base of the shifter boot (7) next to the console. Be careful not to damage the boot. This will separate the boot and inner trim ring from the console.

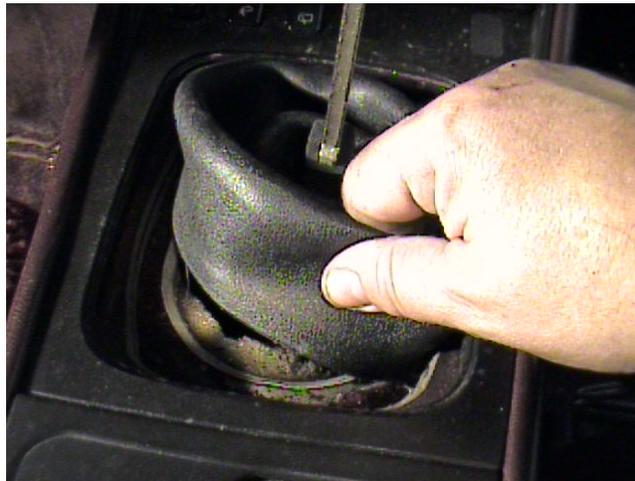
- b. Using a probe or small flat tip screwdriver, remove the clip (2) which holds the shift knob (3) to the shift lever (1).
- c. Pull up on the shift knob to remove the knob and boot from the shift lever.
- d. Pull up on the rubber inner boot (6) to separate it from the shifter sound absorber (8).

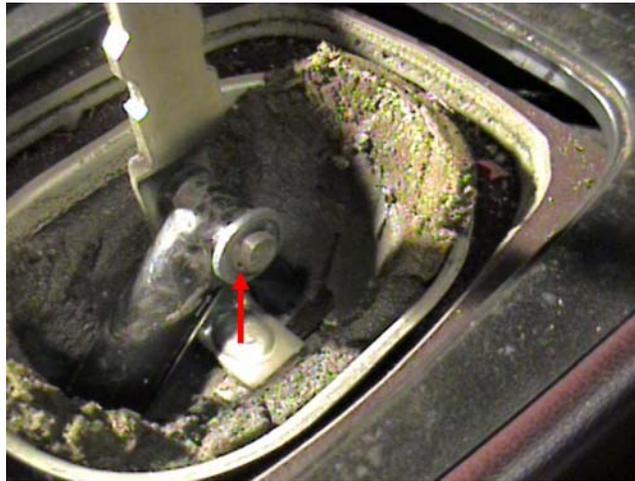
- d. Go To Step 4.
4. Disconnect the shifter rod (14, 16) from the shift lever as follows:
 - a. On 944s, remove the "C" clip (16) from the groove on the shift lever pin. Be careful not to drop the clip. Then, slide the shifter rod off of the pin. Remove the washer (15) from the pin and set aside.

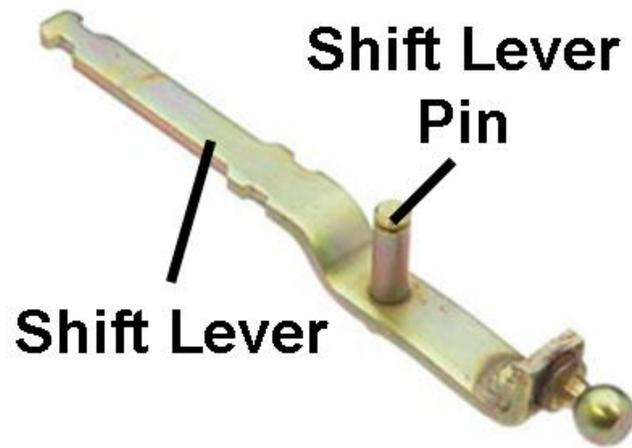
- b. On 968s, remove the spring clip (17) from the groove on the shift lever pin. Remove the washer (18) and bushing (19) from the shifter rod. You may have to slide the shifter rod off of the shift lever pin to remove the bushing. Remove the other bushing from the shifter rod and the remaining washers from shift lever pin.

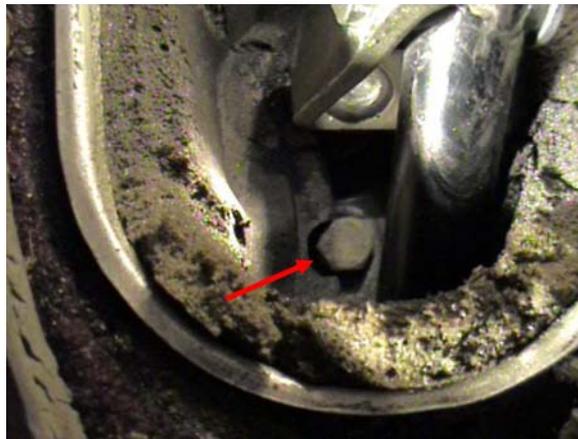
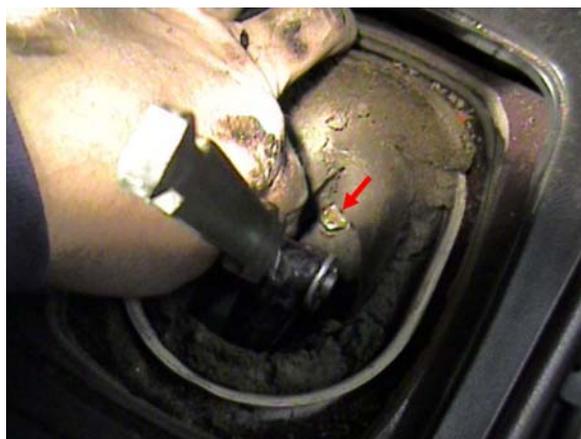
5. Inspect the shift lever pin for wear. If it is excessively worn, the pin will be tapered instead of the same diameter along its entire length. If the pin shows excessive wear, replace it. On 968 shift levers, it is more likely that the shift lever bushings (2) will be worn instead of the pin. Check the bushings by sliding them onto the shift lever pin and looking for excessive play. If the bushings show excessive wear, replace them.
6. Next, remove the shift lever from the vehicle by removing the two bolts (13, 15) that hold the bearing bracket (9, 11).

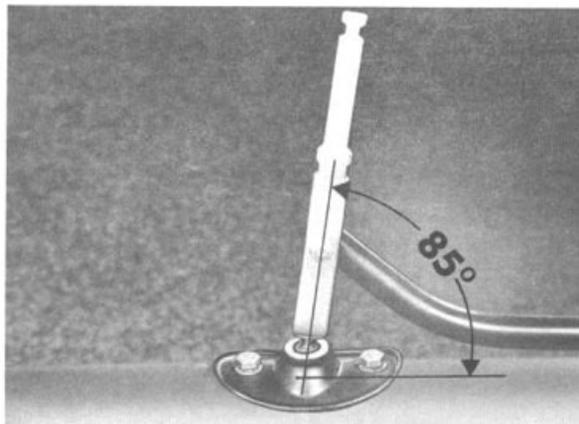
1. With the shift lever set to neutral, the shift lever should be inclined toward the rear of the car at an 85° angle.

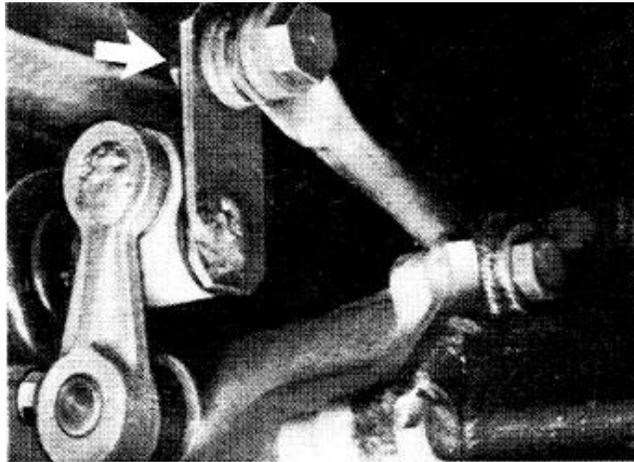
2. If the shift lever is not at the proper angle, loosen (but don't remove) the two bolts for the shifter bearing bracket and slide bracket forward or backward as necessary to obtain the correct angle on the shift lever. Then tighten the two bolts.
3. Also, with the shift lever in neutral, the shift lever should be no side-to-side inclination. In other words, it should not be leaning to the left or right. If so, the side-to-side inclination must be adjusted at the transaxle.
4. To adjust the side-to-side inclination on a 944, perform the following:
 - a. Loosen the lock nut on the intermediate shaft linkage (see picture below).

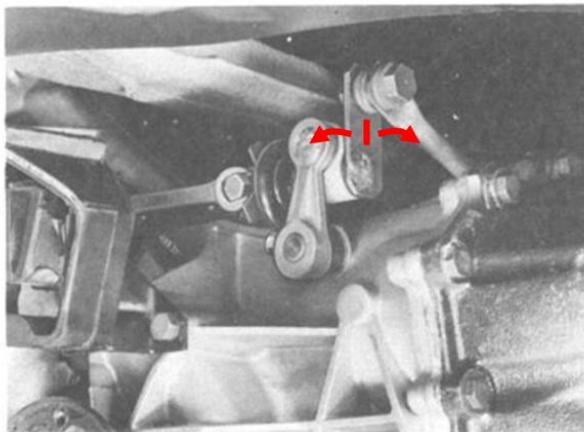
- b. Move the intermediate shift lever to the left or right to change the inclination of the shift lever on the console. Moving the intermediate shift lever to the driver's side of the car will incline the shift lever on the console more toward the driver's side. Moving the intermediate shift lever to the passenger's side of the car will incline the shift lever on the console more toward the passenger's side.

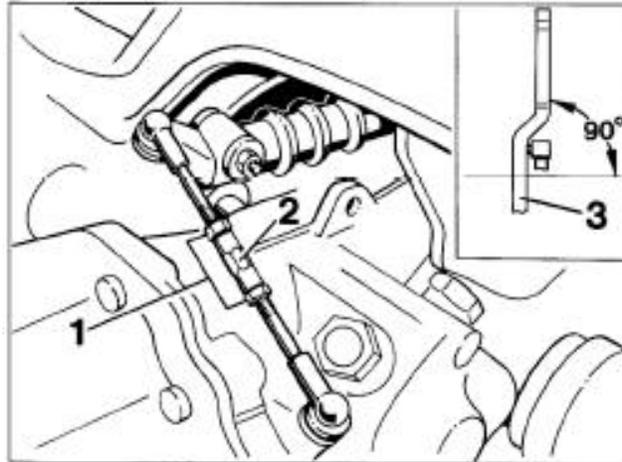
5. To adjust the side-to-side inclination on a 968, perform the following:
 - a. Loosen the locknuts (no. 1) on the intermediate shift lever adjustment turnbuckle and turn the center piece (no. 2) until there is no side-to-side inclination at the console shift lever (no. 3).

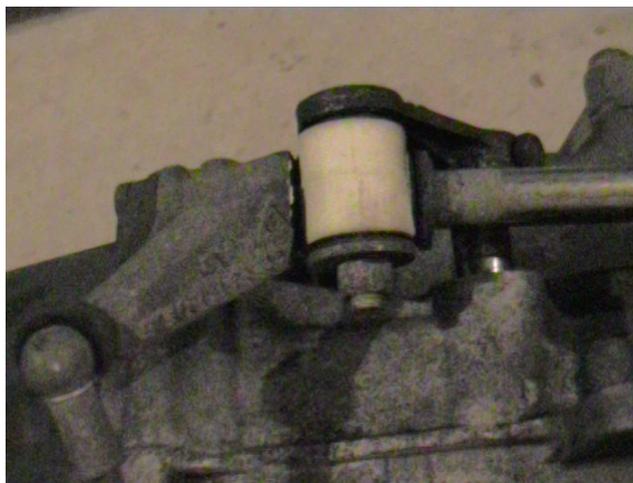
The intermediate shift lever at the transaxle shift linkage is partially made of hard plastic (white part in the picture below). Over time the plastic can wear out causing the shifting to become sloppy. If you have already checked and/or replaced the shift lever and shift lever bearing or shift lever bushings (968 only) and there still seems to be some sloppiness to the shifting, inspect the intermediate shift lever for excessive play.
